# HP Compaq Presario CQ56-110US Repair Wi-Fi Card Replacement

Use this guide to fix wireless connectivity issues by replacing the defective wifi card on the HP Compaq Presario CQ56-110US laptop.

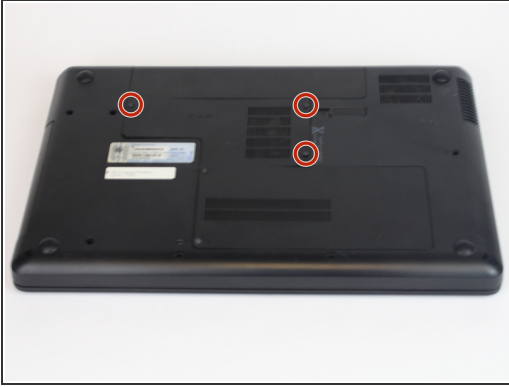
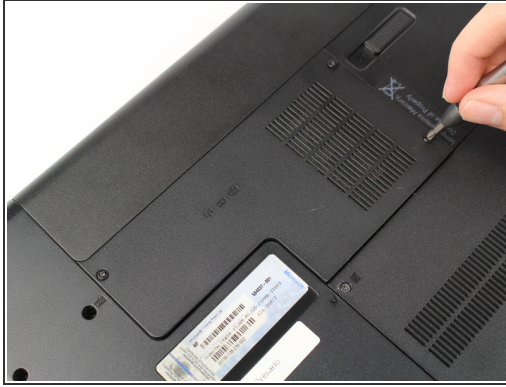
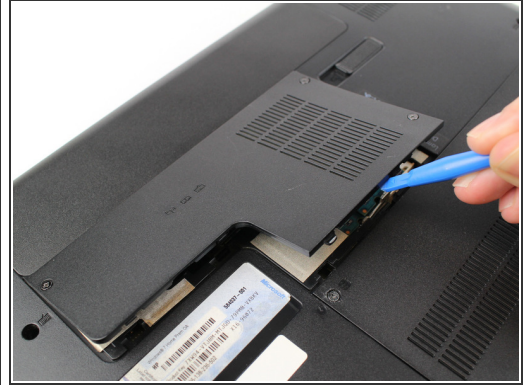
## Step 1 — Wi-Fi Card

- Use a Phillips screwdriver with a PH1 bit to loosen the three indicated screws.
- ⓘ The screws do not come free from the panel. They only need to be loosened enough so that the panel can be lifted/pried using a plastic opening tool.

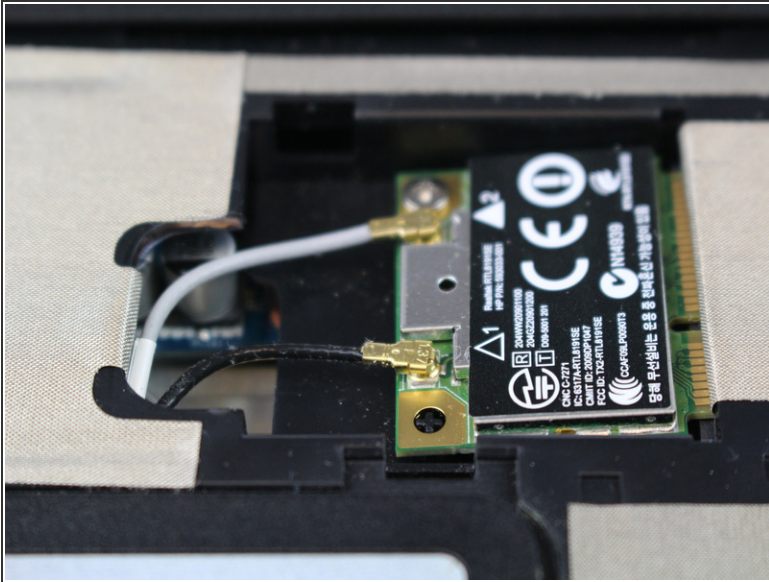
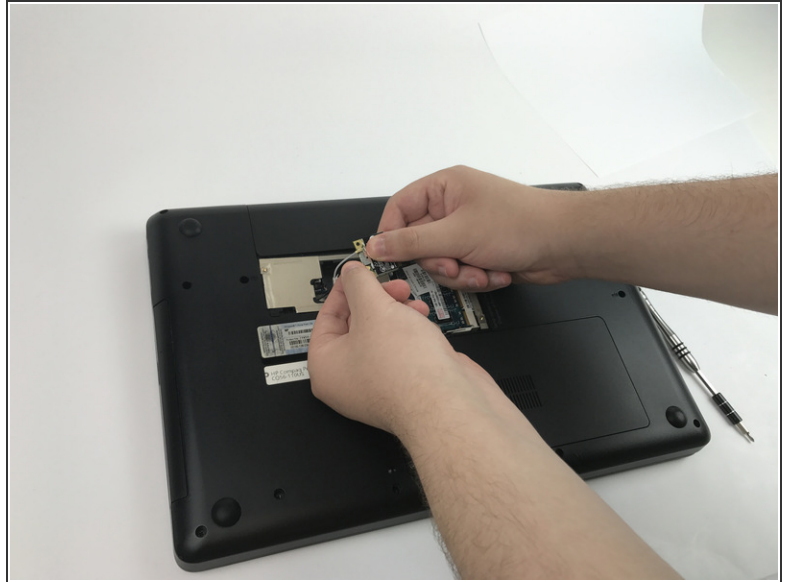
## Step 2

- Gently pull the black and white cables to disconnect them from the Wi-Fi card.

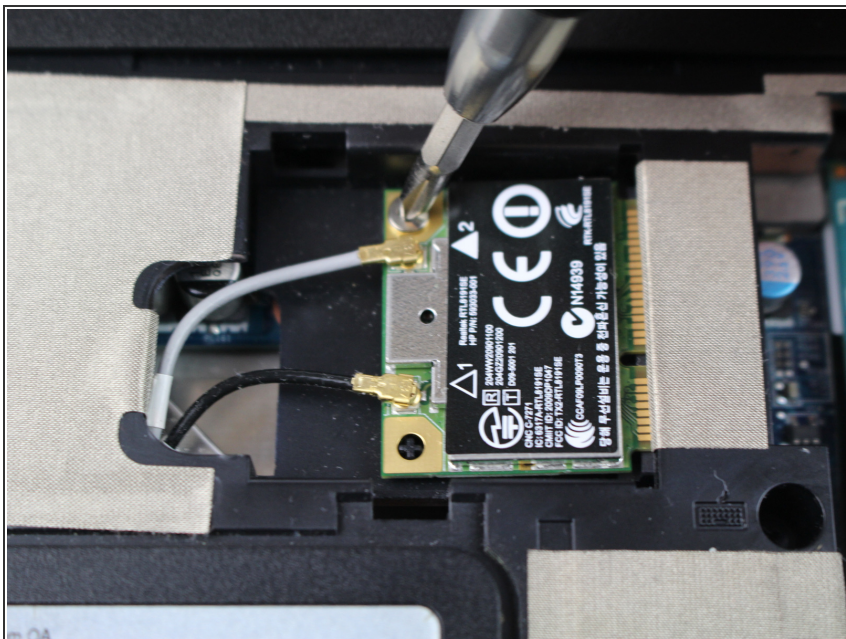
### Step 3

- Use the same screwdriver to remove the two 3 mm screws holding the card in place.

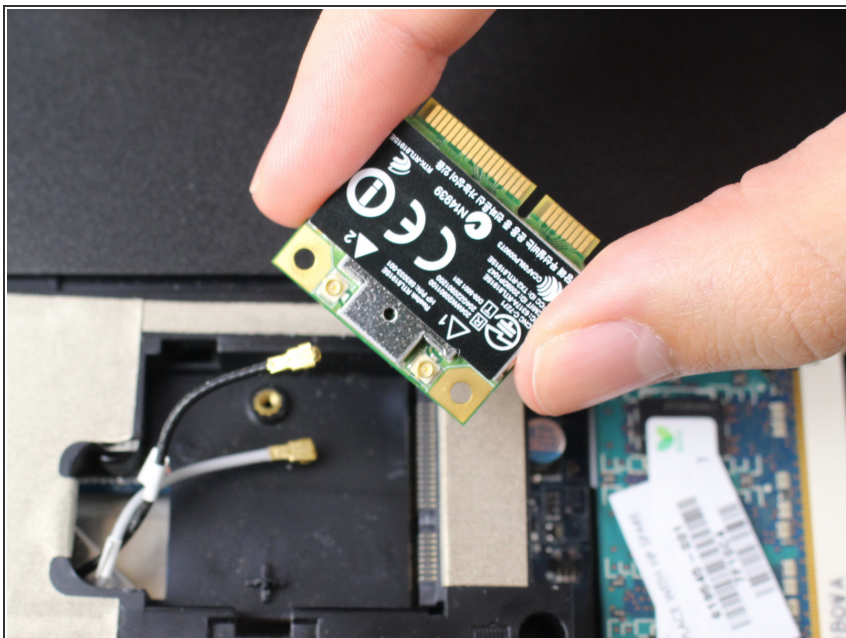
### Step 4

- Lift the Wi-Fi card to remove it from the slot.

To reassemble your device, follow these instructions in reverse order.
